Orlando, Florida  
April 24-27, 2005

## TRENCHLESS REHABILITATION OF THE INDIAN ROCKS BEACH FORCE MAIN REPLACEMENT

William H. Gill, PE<sup>1</sup> and Dorian Modjeski, PE, DEE<sup>2</sup>

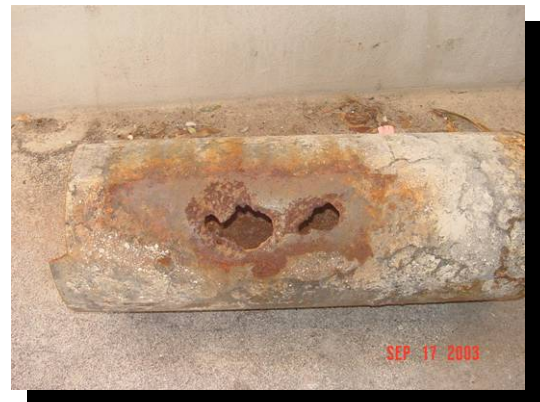
Over the last ten years, and more recently, the force main has experienced a number of breaks, most often occurring on the easterly side of the Intracoastal Waterway in the Shipwatch Condominium Complex and the McKay Creek Wastewater Treatment Plant (WWTP) site. Probable causes of pipeline failures are due to corrosive soils, possible stray electric currents, and hydraulic surges in the pipeline.

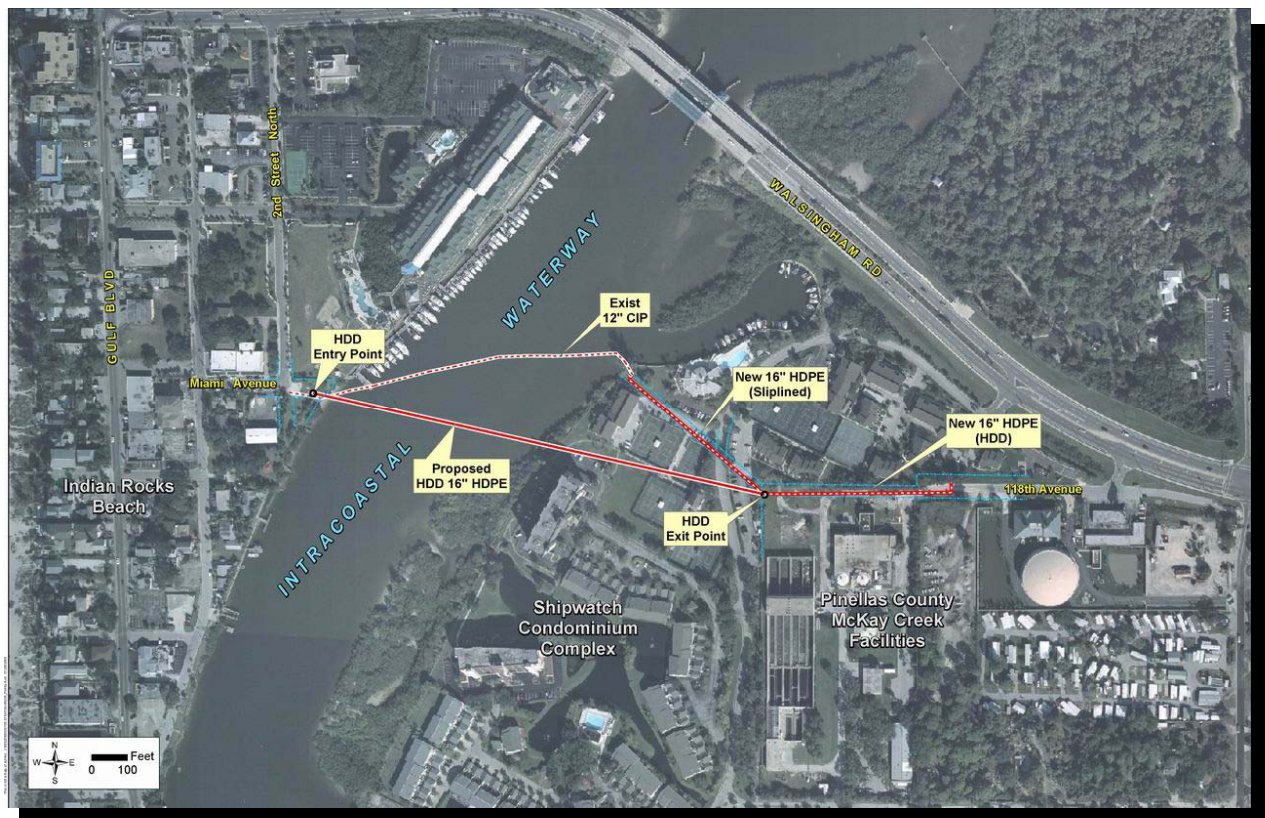
**Figure 1**

Several alternative pipeline alignments for the proposed HDD crossing were considered and evaluated. In general, the alignments followed the existing pipeline with the drilling and pull-back operations being positioned on either side of the Intracoastal Waterway. The recommended alignment, which did not follow the existing pipeline, has the drilling and pull-back operations located on the west side of the Intracoastal Waterway and the pipeline layout and fabrication site on the County's McKay Creek property. See Figure 1.

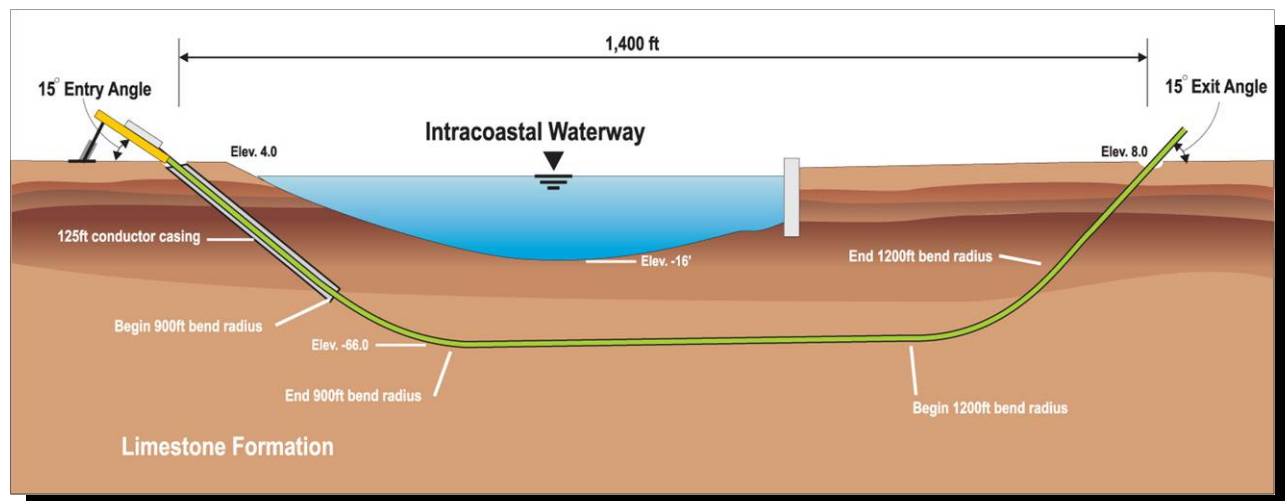
Figure 2

Alternative profiles were evaluated by TBE Group during pipe design. The final profile is shown in Figure 2.

The final profile was chosen based on the feasible entry and exit angles, establishing the depth to keep the majority of the steering operations in reasonably uniform soils, and maintaining the original entry and exit points.
