Orlando, Florida  
April 24-27, 2005

## TRENCHLESS REHABILITATION OF THE INDIAN ROCKS BEACH FORCE MAIN REPLACEMENT

William H. Gill, PE<sup>1</sup> and Dorian Modjeski, PE, DEE<sup>2</sup>

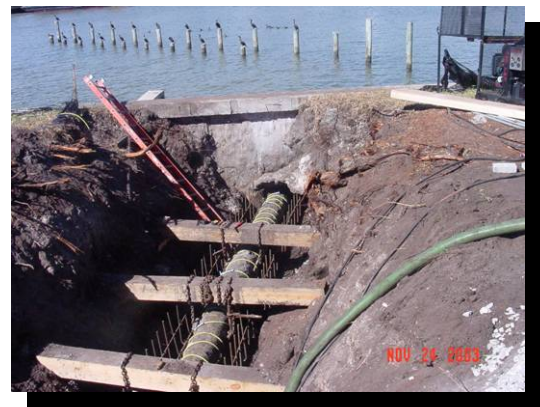
Once the new HDPE pipe sections were constructed and tested, connections to the existing force main took place. At the downstream end, the connection was made to a relatively new section of polyvinylchloride (PVC) pipe using a pressure tap fitting and valve including a line stop. At the sea wall location, the connection was made by a wet tie-in to the existing cast iron pipeline. The cast iron pipe was found to be severely encrusted with marine growth and its overall integrity questioned raising concerns over risk of imminent rupture. A special reinforced concrete encasement was designed and constructed to accomplish the connection. The pipe was initially excavated to the spring line. The pipe was then hand excavated in short segments and was supported from overhead cross beams spanning the trench. At the hanger locations, wood blocking was used to avoid point hanger loads on the pipe. The work was scheduled during periods of low flow between midnight and 5:00 AM. During this time, the pump station was shut down and vector trucks were used to assist with the draining of the 12-inch cast iron force main and to provide emergency back-up at the pump station, if necessary.

Due to the poor foundation conditions the concrete encasement was supported on screw piles. To improve the water tightness of the encasement in the event a leak developed, the pipe was wrapped with perforated PVC tubing that would permit the injection at the pipe/concrete interface with a hydrophilic compound to stop potential leaks.

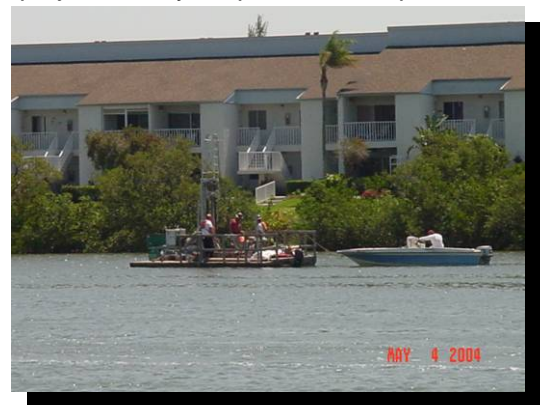
A geotechnical investigation was undertaken to examine subsurface soil and ground water conditions for use in design and construction. Marine test borings were conducted utilizing a drilling rig supported by portable barges along the general alignment and off the proposed centerline of the directional drilling beneath the Intracoastal Waterway. The test borings were offset from the proposed center line to prevent the loss of drilling fluid during the crossing installation. The project surveyors provided the position of these borings and also surveyed the mud-line elevation at the time of the test borings. Results of the geotechnical borings indicate that the soil profile can be grouped into two zones for the purposes of HDD design. The upper zone from ground surface to approximately 18 feet deep, or elevation -14 is predominantly medium dense to very dense sand and clayey sand and stiff to very stiff clay. The lower zone from approximately 18 feet deep to bottom of borings is predominantly stiff to hard clay and limestone layers. One of the borings indicated a 100-percent loss of fluid circulation at elevation -20 feet. The geotechnical investigation also indicated the presence of unfilled dissolution features at varying depths which is common for the region. The presence of these solution features creates the potential for preferential seepage paths for the migration of drilling fluids to the surface during the pilot bore and reaming operations. To mitigate the potential for inadvertent surface returns or frac-outs, the contractor will be required to install a conductor casing at least 125-feet long at the drill rig entry side. The conductor casing should be approximately 36-inch diameter steel pipe with a minimum wall thickness of ½ inch or thicker, if necessary to support installation loads. The conductor casing is needed to prevent drilling fluid from leaving the borehole by hydrofracturing the soil formation or through unfilled solution features. The conductor casing will be installed to a depth at or below the transition into the hard clay and limestone region. Below this region, the formation strength and confining pressure will be sufficient to prevent hydraulic fracturing of the soil strata and the potential of solution features providing a seepage path to the surface is greatly reduced. Near the exit location, hydraulic fracturing may occur when the soil confining pressure is exceeded by the downhole fluid pressure. The HDD contractor will be required to have cleanup and containment supplies on site (including a vac-truck, hay bales, silt fence, straw wattles, etc.) and a contingency plan in place to quickly contain drilling fluids.

The presence of these solution features creates the potential for preferential seepage paths for the migration of drilling fluids to the surface during the pilot bore and reaming operations. To mitigate the potential for inadvertent surface returns or frac-outs, the contractor will be required to install a conductor casing at least 125-feet long at the drill rig entry side. The conductor casing should be approximately 36-inch diameter steel pipe with a minimum wall thickness of ½ inch or thicker, if necessary to support installation loads. The conductor casing is needed to prevent drilling fluid from leaving the borehole by hydrofracturing the soil formation or through unfilled solution features. The conductor casing will be installed to a depth at or below the transition into the hard clay and limestone region. Below this region, the formation strength and confining pressure will be sufficient to prevent hydraulic fracturing of the soil strata and the potential of solution features providing a seepage path to the surface is greatly reduced. Near the exit location, hydraulic fracturing may occur when the soil confining pressure is exceeded by the downhole fluid pressure. The HDD contractor will be required to have cleanup and containment supplies on site (including a vac-truck, hay bales, silt fence, straw wattles, etc.) and a contingency plan in place to quickly contain drilling fluids.

A relief well will be installed by the contractor near the exit location of the proposed HDD bore. The relief well will be designed to intercept and relieve excessive formation pressures created by the pressurized drilling fluid that could cause hydrofracture as the soil cover decreases. The relief well will be located between the tennis courts and Shipwatch Drive. The relief well will be installed with a 10-foot long screened/perforated interval and with the tip elevations five feet above the crown of the proposed HDD
